EXPERIMENTAL INVESTIGATION OF RIM CRACKING IN DISKS
SUBJECTED TO HIGH TEMPERATURE GRADIENTS

By P. I. Wilterdink

Lewis Flight Propulsion Laboratory Cleveland, Ohio

WASHINGTON
September 1, 1949

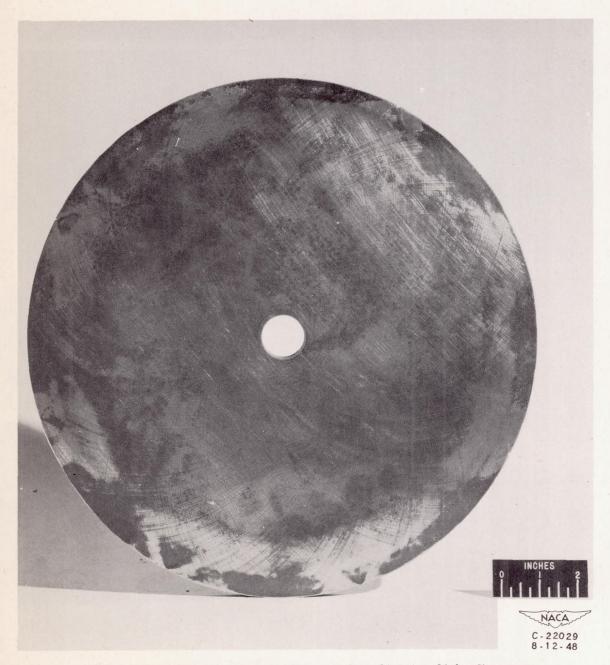
It was impossible to produce cracking at the notches in the rim under the previously described conditions. The flat disk was subjected to approximately 200 thermal-stress cycles and the tapered disk was subjected to approximately 20 cycles in which the maximum rim temperature was 1350°F. The conditions of the disks after the runs are shown in figures 12 and 13. The dark areas at the bottoms of the notches were brought out by removing the scale with a piece of emery cloth, which was supported by a flat piece of steel. These areas were depressions somewhat below the surface of the disks. The center parts were the regions of greatest depression in the dark areas. The areas at the bottoms of the notches resembled plastic-flow figures or Lüders' lines.

Hardness surveys taken after the runs were completed showed that the hardness at the edge of the rim was approximately Rockwell C-10. On the tapered disk, which had been subjected to only 20 thermal-stress cycles at 1350°F, the reduction in hardness

Figure 12. - Condition of SAE 1045 13.5-inch-diameter disk after runs.
